# FURE'S CABIN

## HISTORIC STRUCTURE REPORT

FURE'S CABIN

KATMAI NATIONAL PARK & PRESERVE

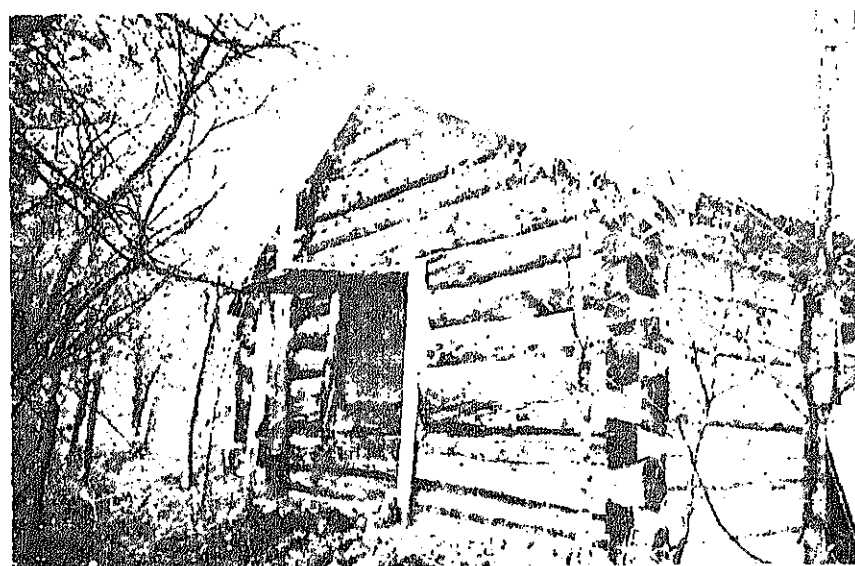
Photograph 3

The roof planks are sheathed with corrugated metal at the exterior. There are signs of rot at the butts of many of the planks because the corrugated metal does not uniformly cover the last inch of the plank. Water running off the roof is being soaked up into the end-grain and causing damage. It should be noted that the end-grain of the roof planks and the corrugated metal have all been treated historically with what appears to be red paint, similar to that found on wall corners.

West Elevation: Note Deteriorated Condition of  
Roof Planks

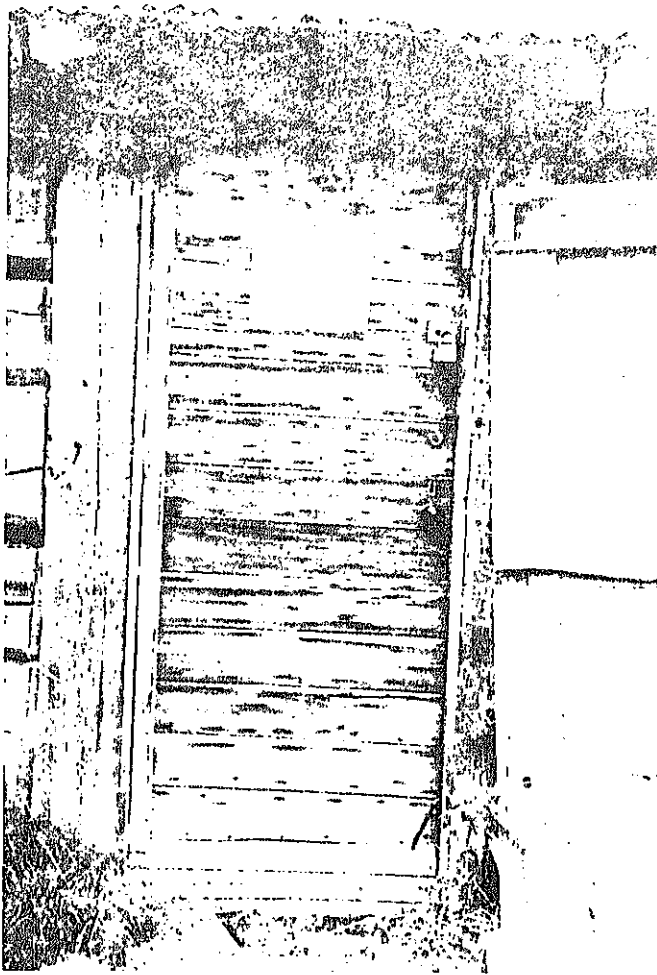
Photograph 16  
Roof Plank Edge at North End of  
West Elevation  
6/28/83 D.C. Anderson

There is also visual evidence of a roof leak at the north end of the west wall that is directly affecting floor planks in that vicinity. Planks are generally mushy near sill walls and bearing points evidencing direct moisture contact.

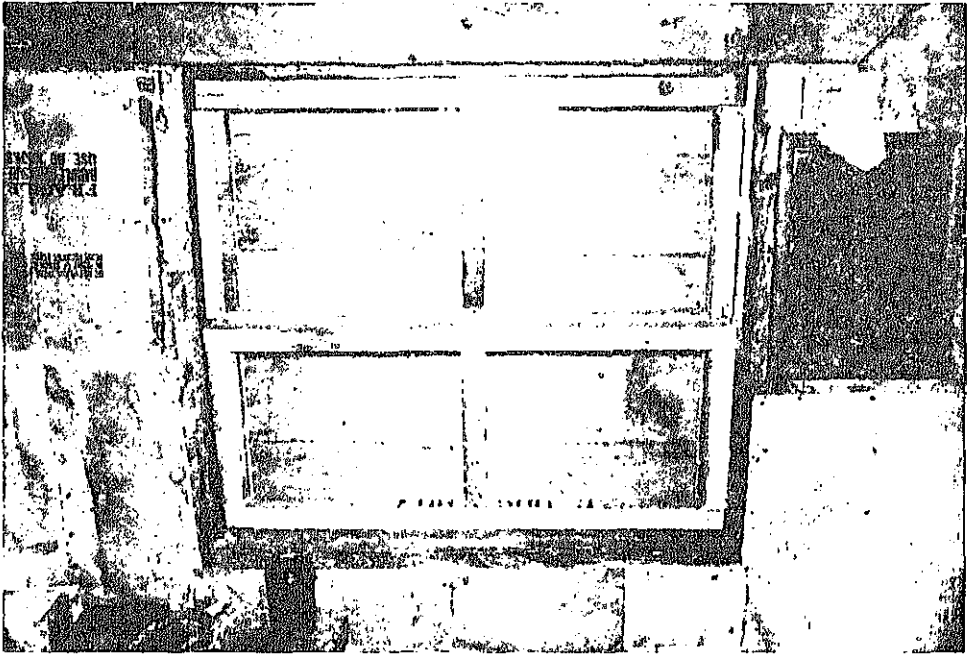
Photograph 43  
Typical Dovetail Joint: Note  
Paint on End Grain  
6/82 D. Snow

The corner joints are all dovetailed with a high degree of craftsmanship and still fit tight. At various points there is evidence of large spikes having been driven into the dovetailed joints. All end-grain of these joints is painted with red paint. The paint appears to have been a regular maintenance operation in the upkeep of this structure performed by the owner, Roy Fure. The paint has remained in fair condition, thus slowing deterioration at the log butts.

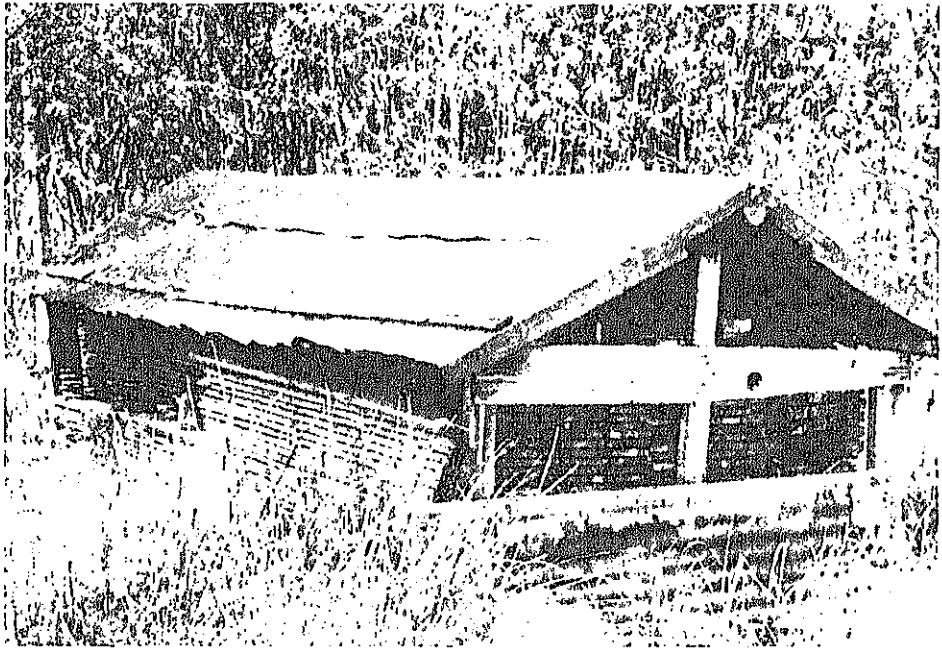
Photograph 49  
Storage Shed  
6/82 D. Snow

3. A storage shed for lumber, measuring about 4' x 15' and standing about 4' high, is about 50' south of the cabin. This structure consists of 2x4 studding and a tin roof. It was built without walls. Condition of the shed is good.

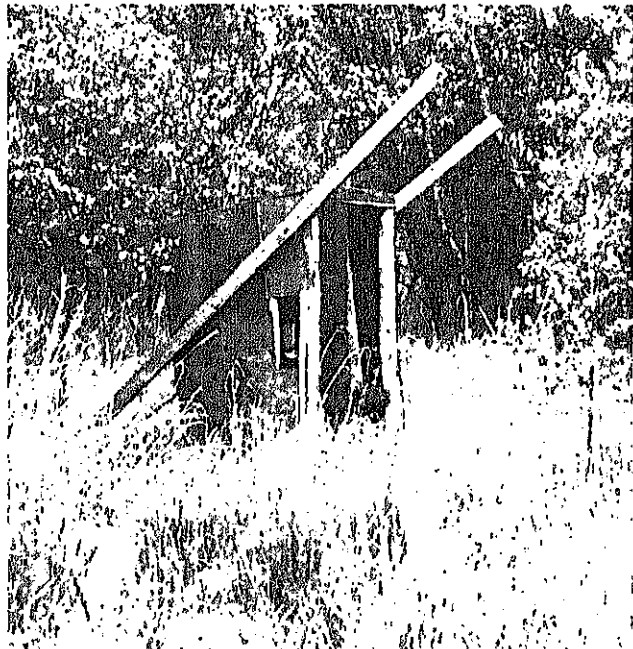
Photograph 50  
South Elevation of Out-House  
6/82 D. Snow

5. An outhouse is about 20' southeast of the cabin. It is constructed of planed lumber and poles. The condition is good.

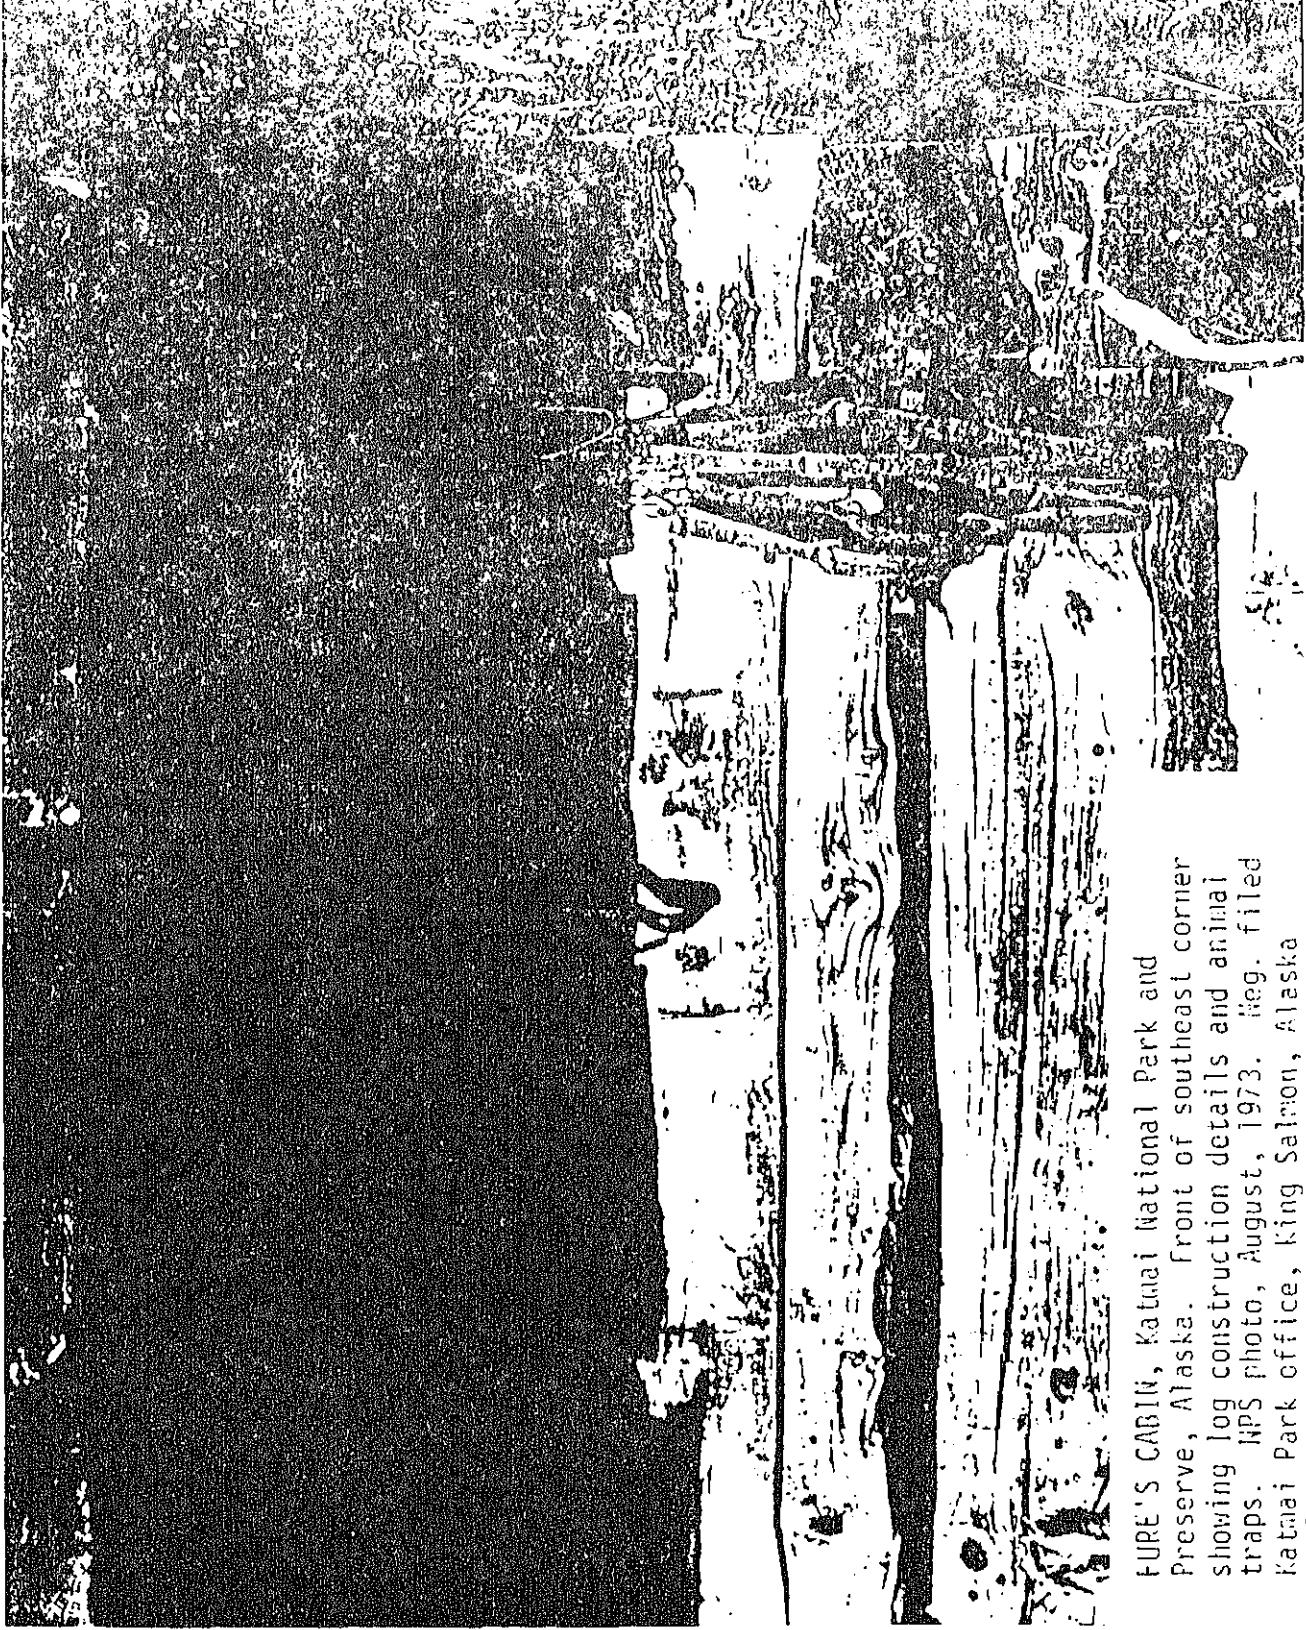
FURE'S CABIN, Katmai National Park and Preserve, Alaska. Front of southeast corner showing log construction details and animal traps. NPS photo, August, 1973. Neg. filed Katmai Park office, King Salmon, Alaska 00612

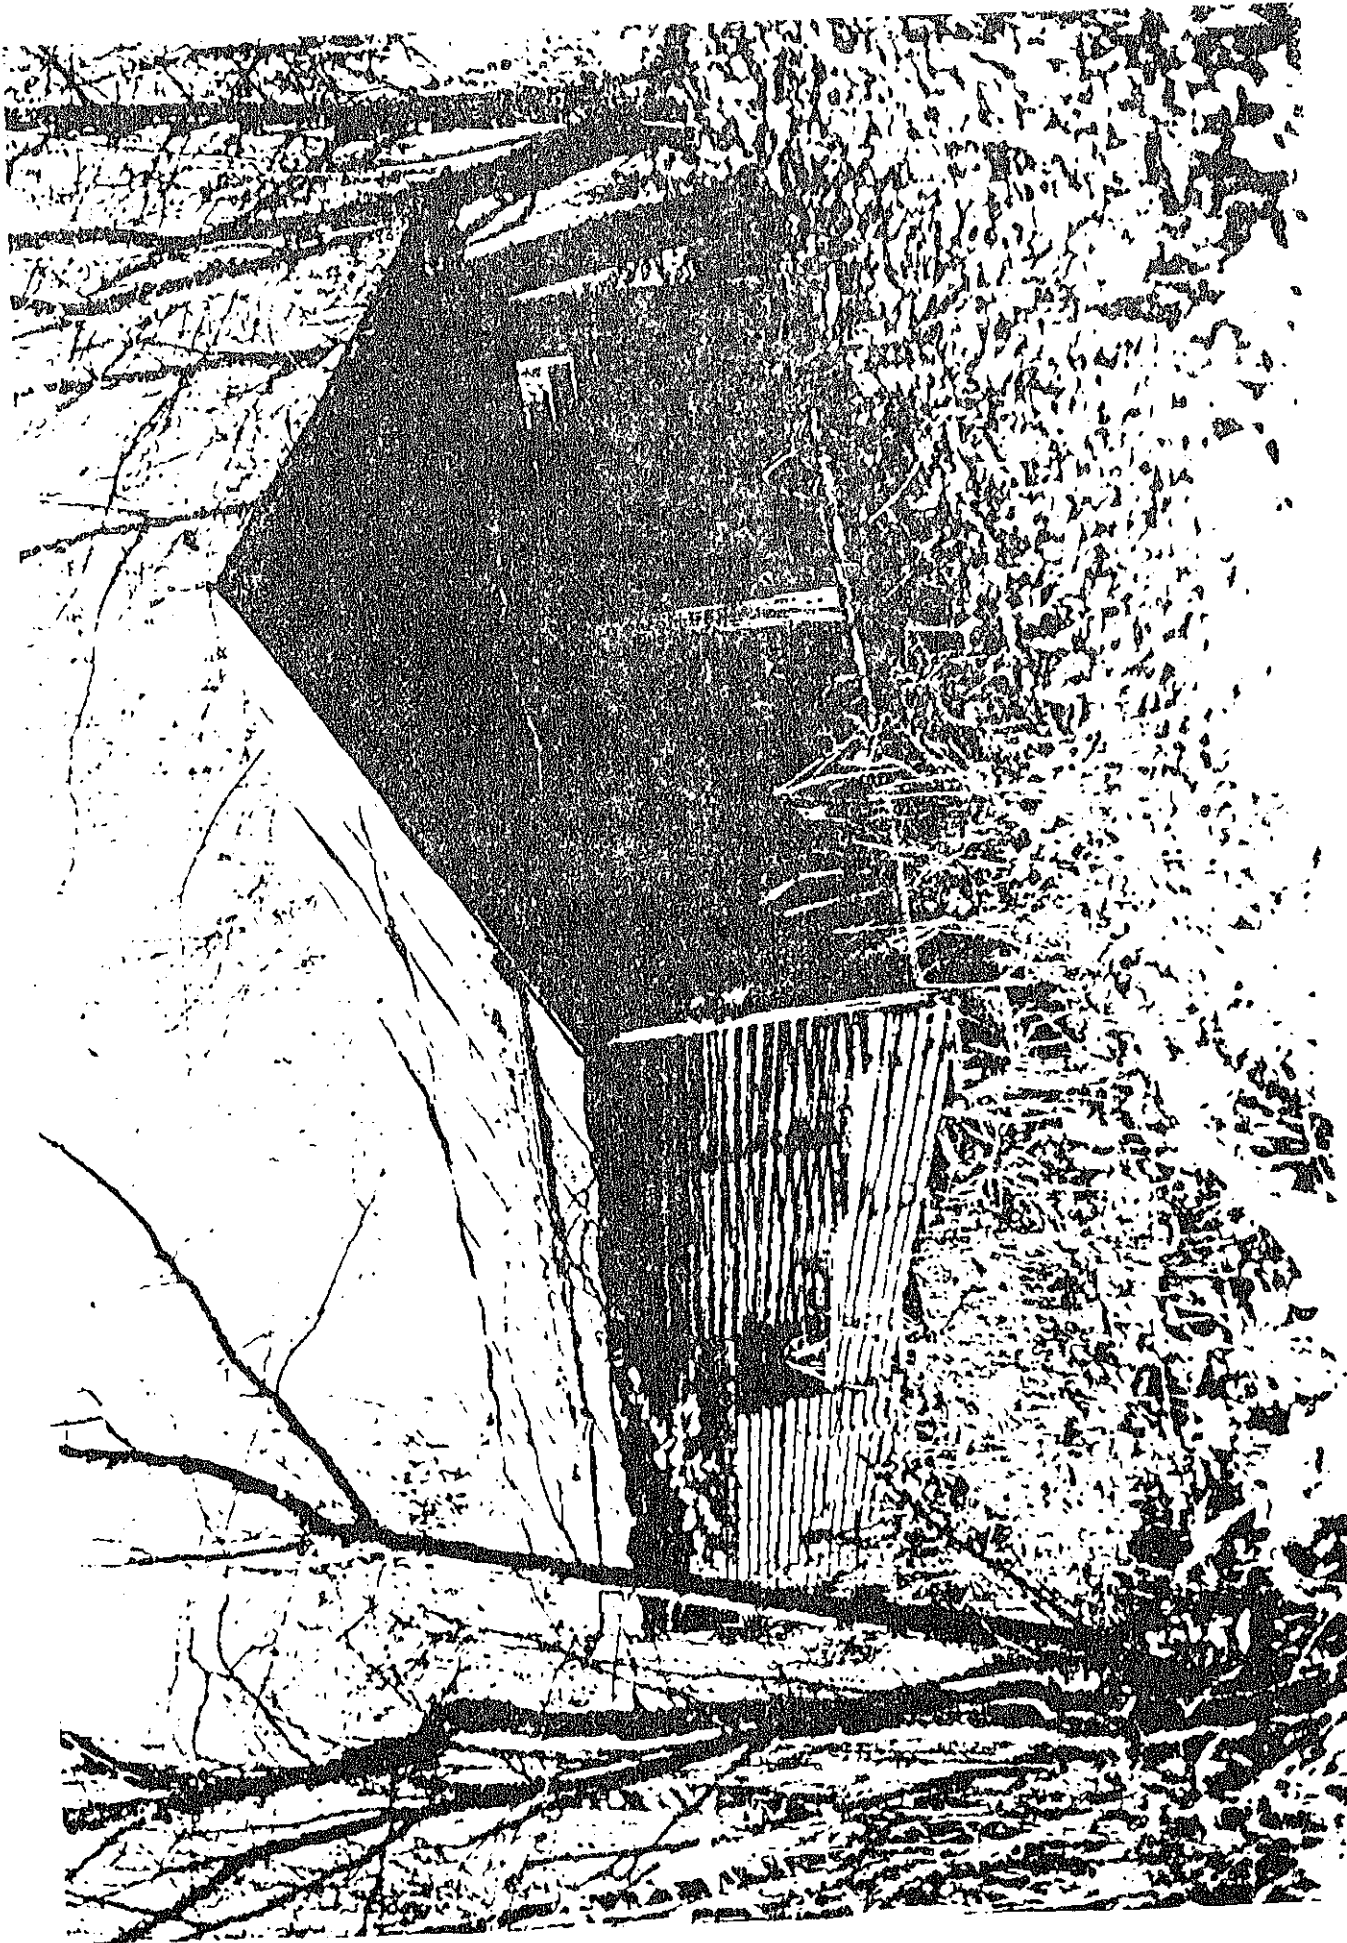
Pure's Cabin, Katmai National Park and Preserve, Alaska. NW view of storage shed for lumber. NPS photo, Sept. 1983. Negative filed at Alaska Regional Office, NPS, Anchorage, Alaska. J. Estus.

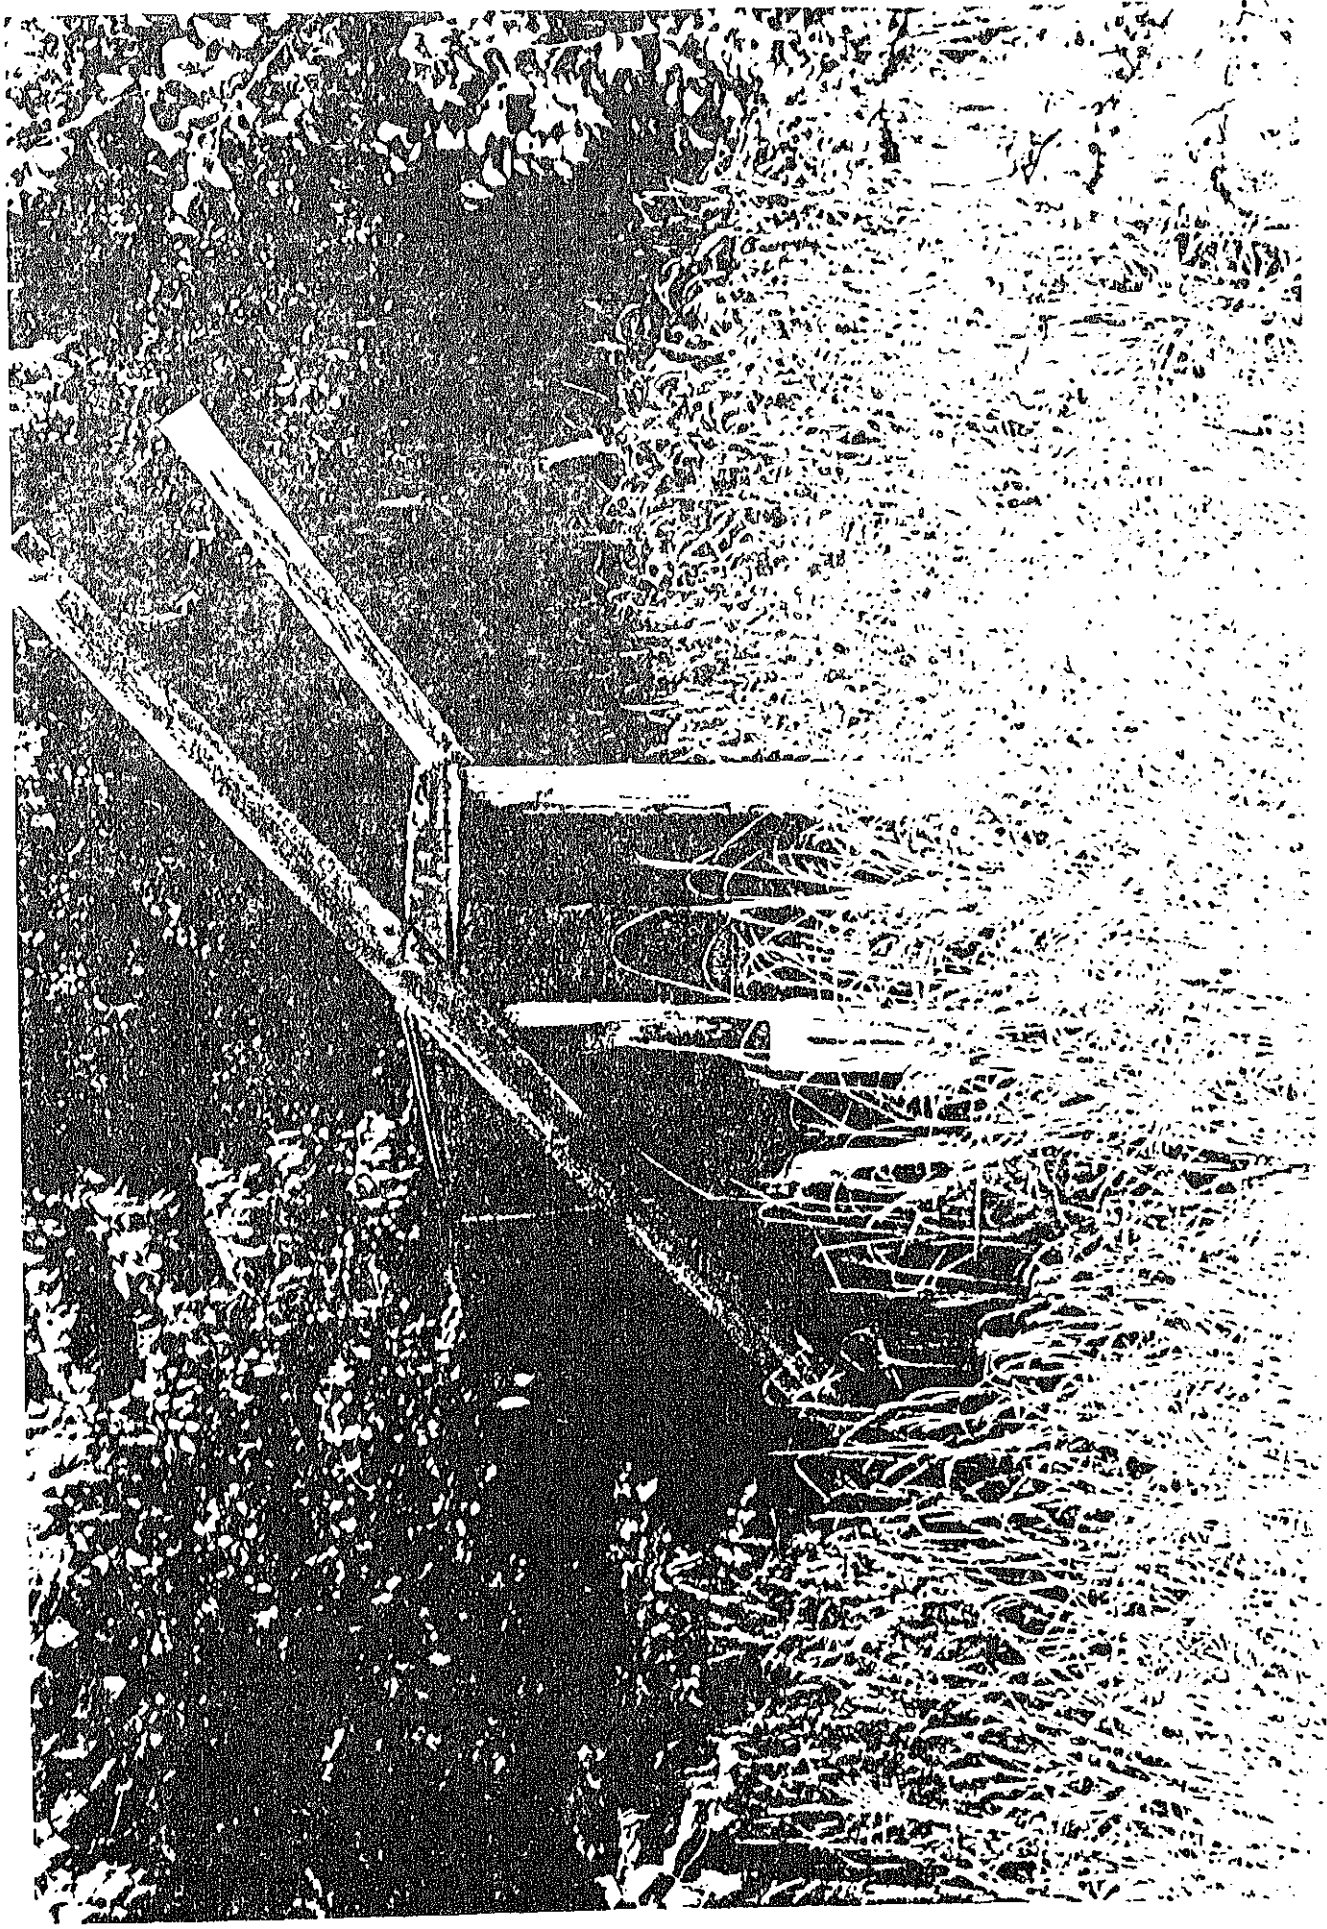
Fure's Cabin, Katmai National Park and Preserve, Alaska. Outhouse located about 20' southeast of cabin. NPS photo, June, 1983.  
negative filed: Regional Architect's files,  
Klondike Gold Rush IIIIP, Skagway, Ak. D. Snow
